KEEPING THE NATIONAL DANISH RAILWAYS ON TRACK WITH PREVENTIVE MAINTENANCE

Case Study

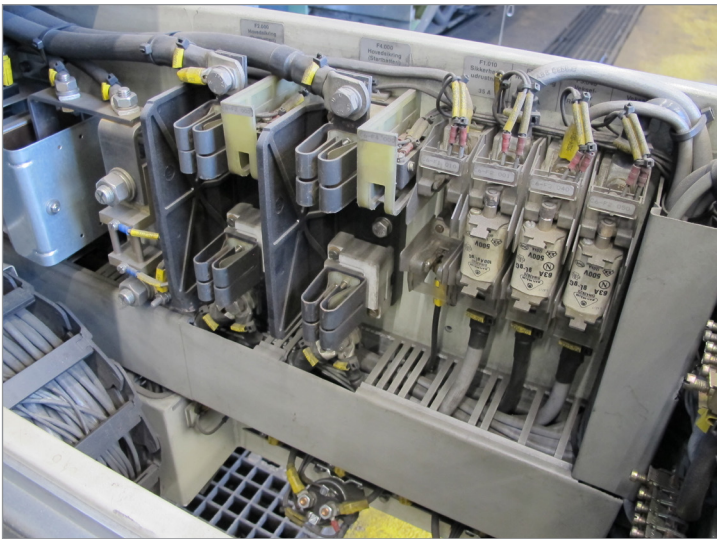
▲ Before Preventive Maintenance

A primary area of focus was to minimize the risk of short circuit damages in electrical drawers and plug connections at the carriage connection joints.

The installations are located in a tough environment and there are microscopic iron materials continuously being worn off from the wheel section of the carriages. These are then spread around when the trains are in motion with the debris potentially contaminating the external technical and electrical equipment of the carriages.

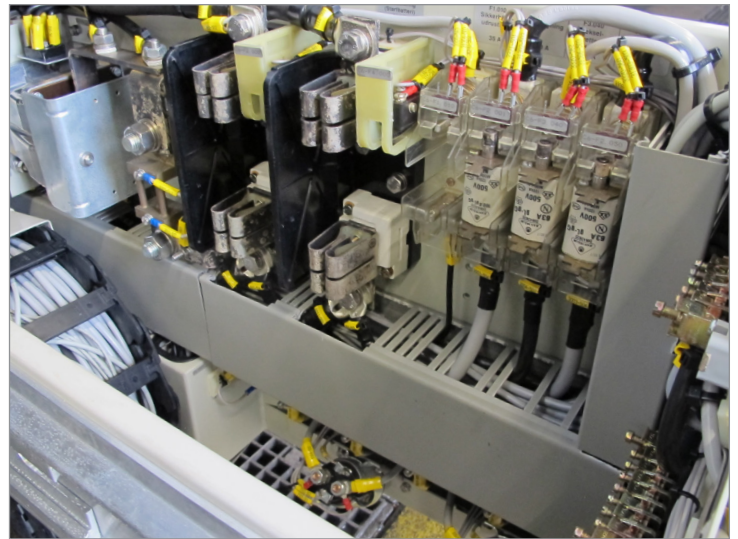
▲ After Preventive Maintenance

The initial inspection was completed in 2018 and a proposal of a schedule preventive maintenance program was presented to DSB. After reaching an agreement on the preventive maintenance program, the AREPA team arrived at DSB’s mechanical shopfloor in Aarhus to clean and execute the preventive maintenance on site on one carriage per week.

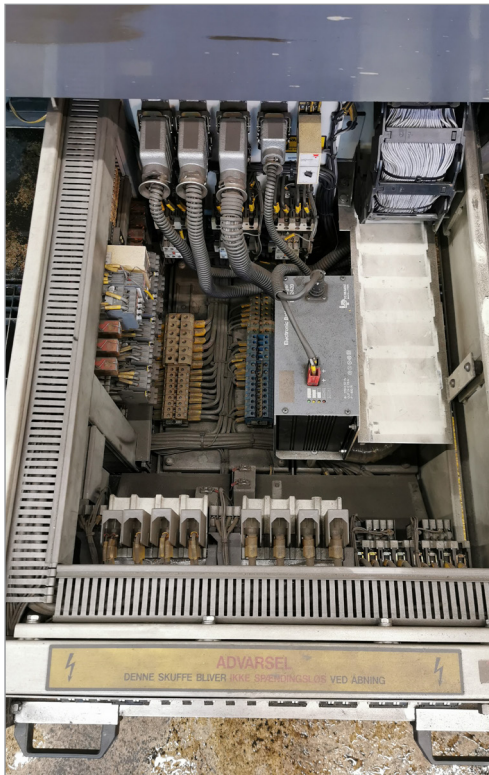
▲ Before Preventive Maintenance

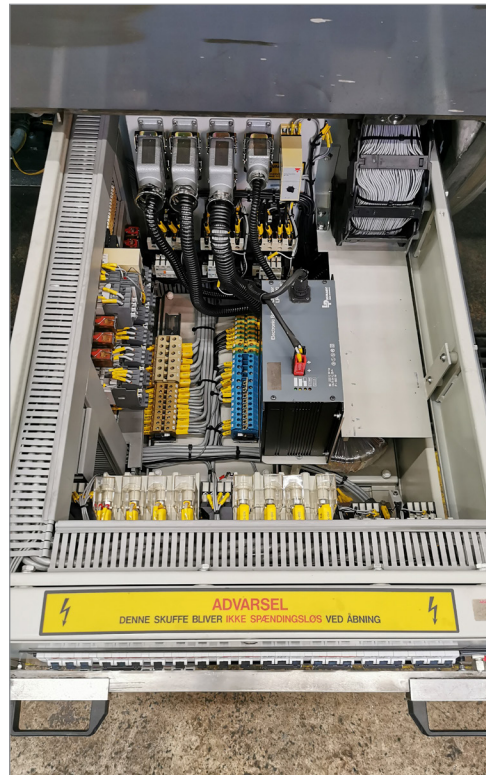
▲ After Preventive Maintenance

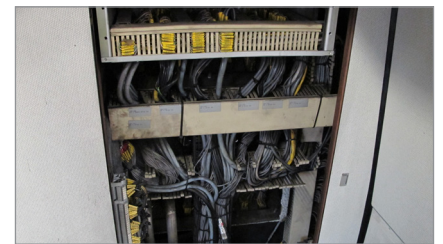
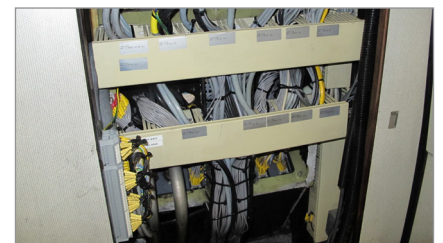
▲ Top photo: before preventive maintenance.
Bottom photo: after preventive maintenance.
